Maine Forestry Best Management Practices (BMP) Use and Effectiveness—Data Summary 2014-2015

Maine Department of Agriculture, Conservation and Forestry

Published May 2016

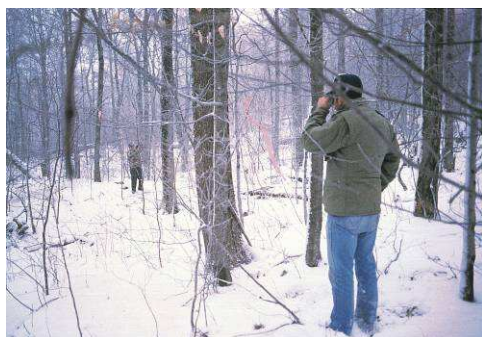
Laying out the harvest on the ground can help identify sensitive areas, reduce skid trails, and avoid unnecessary stream crossings.

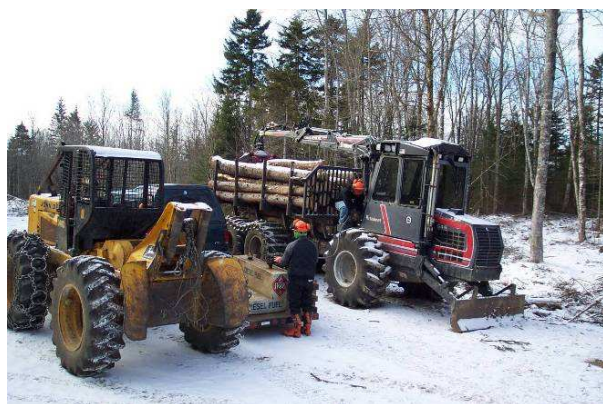
When used properly, carried wood systems (e.g. the forwarder seen on the right) can result in less soil disturbance vs. dragged wood systems (e.g. the cable skidder seen on the left). Regardless of the type of system used, operator skill and training together with proper planning are critical to good results.

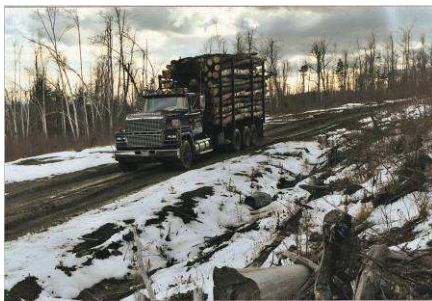
Haul Road

Eighty-one crossings were identified as either haul roads or skid trails; 48 haul roads and 33 skid trails. A haul road may be defined as forest access system designed to transport harvested forest products to a location or facility for resale, sorting or processing into value added forest products. Skid trails are primarily travel routes to bring trees that have been harvested to a concentration point, directly associated with the forest operation notification, for either further preparation for transport on a haul road or public transportation route. Haul road stream crossings were evaluated if they were directly associated with the sample unit. Haul road crossings associated with multiple harvests or large amounts of acreage not directly associated with harvest were not evaluated.

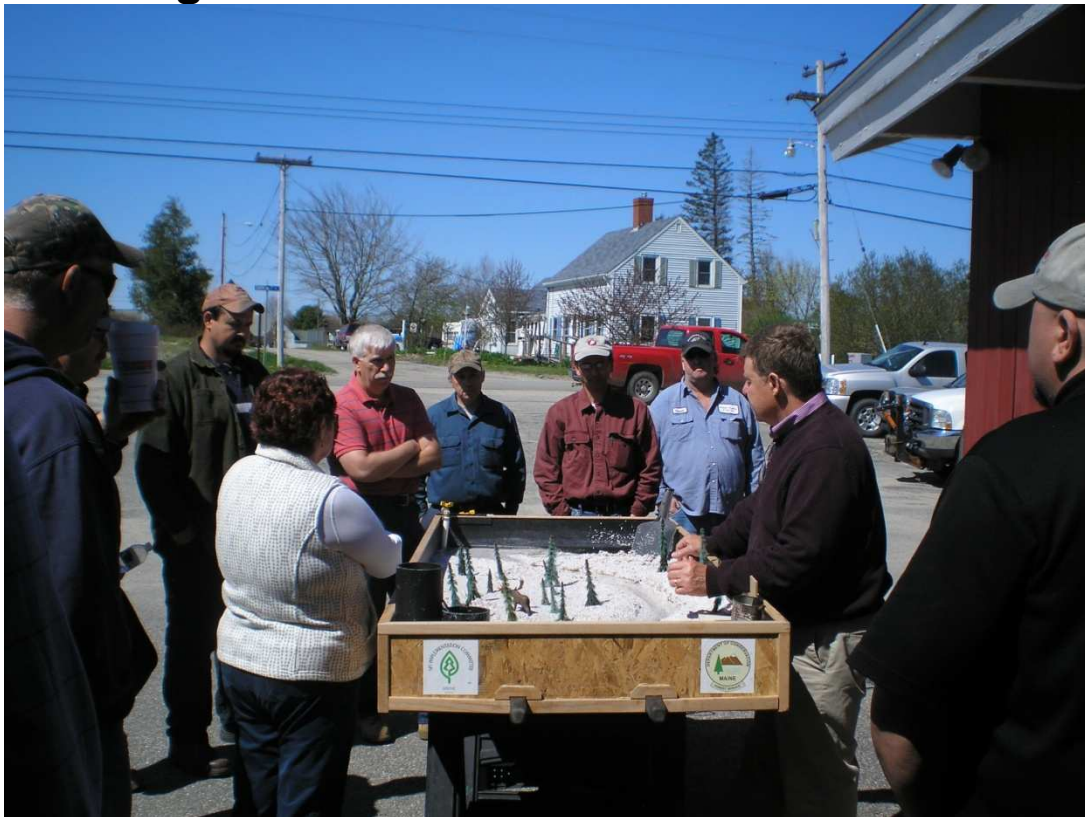
Foresters and loggers discuss the effects of crossing installation using the Sustainable Forestry Initiative (SFI) stream table model during a Maine Forest Service – Maine SFI fish passage training in Whitneyville.
